Re: Hull WPCF Capacity, Management, Operation and Maintenance ("CMOM") Program
Implementation Annual Report
Town of Hull, MA Administrative Order on Consent, Docket No. CWA-01-AO-16-09

CMOM ANNUAL REPORT

Calendar Year 2016

217319.00
Town of Hull, MA
March 2017

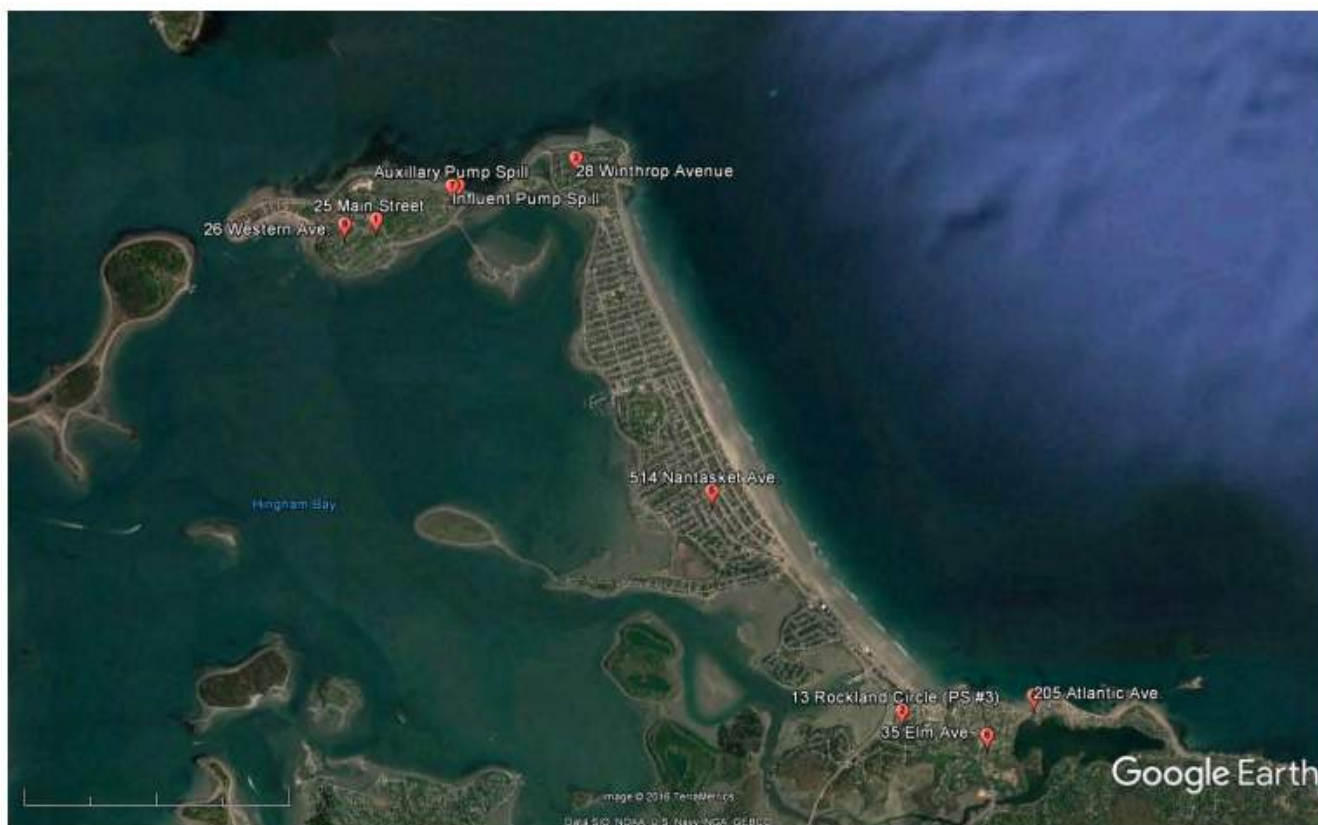
Figure 1: Map of Unauthorized Discharges in 2016

There were nine unauthorized discharge events documented in 2016 (locations shown in Figure 1 below). There were two unauthorized discharges at the WPCF, one unauthorized discharge at Pump Station #3, and three sanitary sewer overflows (SSO's). An additional three SSO's were reported by WPCF staff, but during inspection, found to be privately owned. These SSO's were delegated to the Town of Hull Board of Health to complete follow-up inspections. Brief descriptions as well as current status of each unauthorized discharge are listed in chronological order below, and the full Unauthorized Discharge Summary Table can be found in Appendix D.

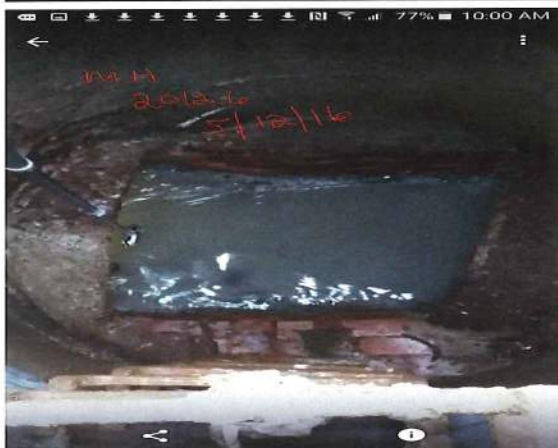
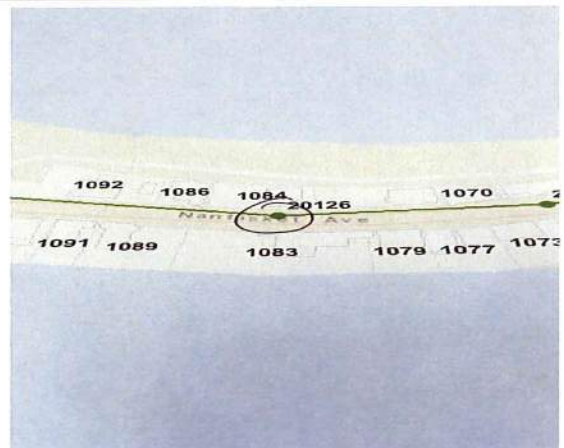
Service: Opened manhole took pictures with GO PRO downloaded in file

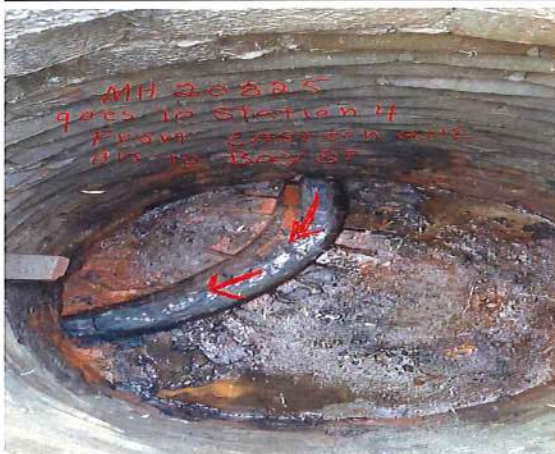
Service: 230pm ES,RC opened manhole 20825, line flowing freely which ends up at station 4

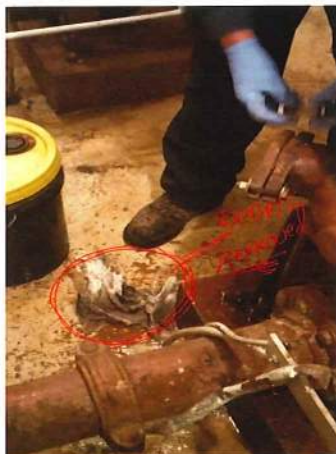
Service: LOTO the pump and remove all the rags and debris from impeller . Flows back to normal now.
Assistance by John Currier, Rick Clark

Shows the debris from the impeller removed,

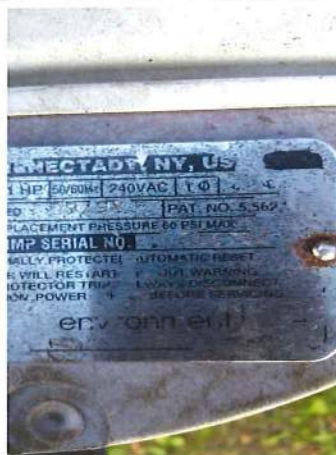
Grinder Pump going in

Service: LOTO Performed. Drained grinder pump pit into tote. Replaced malfunctioning Grinder Pump with Repaired Grinder Pump.

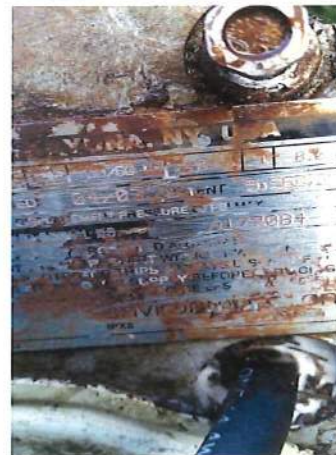
Grinder Pump coming out

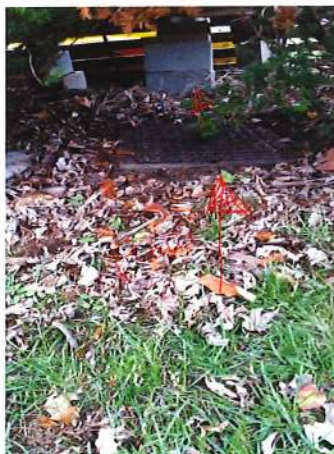
Service: Inspect manholes 20982, 20985 and sure manhole/cleanout in bushes in between #33 and #37. No issues and flowing ok. house no 25, 29,33,37,37A all flow into a lie behind these houses. Clear and flowing. No other cleanout outside. Report back to homeowner.

Cleanout manhole in bushes between #33 and 37

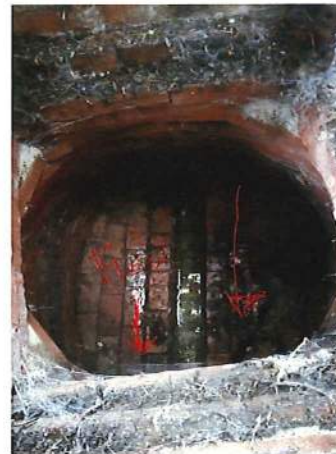
Cleanout manhole in bushes.
